RESULTS OF UNIAXIAL AND BIAXIAL TESTS ON RIVETED FUSELAGE LAP JOINT SPECIMENS

H. Vlieger
National Aerospace Laboratory NLR
Amsterdam, The Netherlands

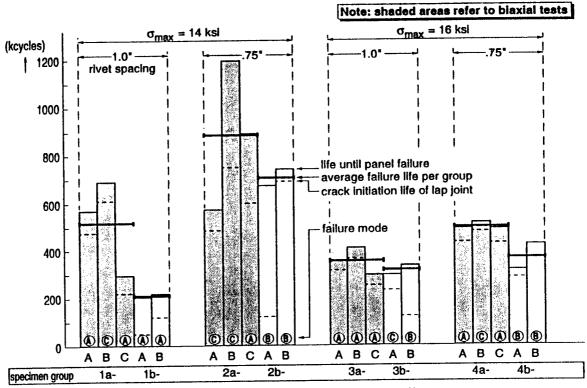
Fig. 6a Crack initiation in lap joints and panel lives until failure (data taken from Table 3)

The diagram in Fig. 6a shows the crack initiation lives of the lap joints and the panel fatigue lives until failure. Further, the average failure life per specimen group and the failure modes are presented. The shaded bars refer to biaxial test results. The test results of the panels with longitudinal stiffeners were omitted.

It can be concluded from Fig. 6a that for each of the 4 groups of specimens in the uniaxial tests crack initiation in the critical rivet row of the lap joint generally started at a lower percentage of panel failure life than in the biaxial tests (see also data presented in Table 3).

Further, on an average in each group the uniaxially tested specimens showed the shortest failure lives. Finally, for both σ_{max} -levels the specimens with the smaller rivet spacings showed the longest mens tested at the lower σ_{max} -values.

It has to be noted here that the uniaxially tested panels with a .75 inch rivet spacing all failed in mode B (i.e. across the tear strap ends, see Figure 5). This implies that the failure lives presented in Figure 6a for these panels are not representative for the fatigue lives of the lap joints but have to be considered as lower bounds thereof. This aspect has to be accounted for with regard to the conclusions drawn above about the fatigue lives found from the uniaxial and biaxial tests. For the uniaxially tested panels with a 1 inch rivet spacing in almost all cases (except for panel 3b-B; see Figure 6a) the fatigue lives of the lap joints determined the panel fatigue lives.

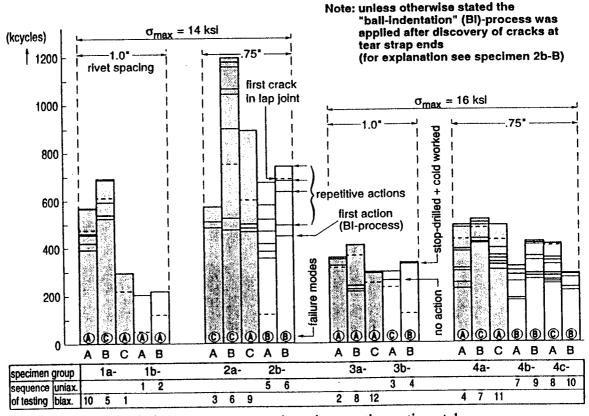
Fig. 6b Crack initiation at tear strap ends and corrective actions taken

During the execution of the testing programme both during the uniaxial and the biaxial tests generally cracks initiated in the skin from the rivet holes at the tear strap ends due to high secondary bending stresses in these areas. When this occurred corrective actions were taken in an attempt to increase the life of the panels to such an extent that cracks in the lap joint would have a chance either still to initiate or to develop further during the continuation of the test. This aspect is illustrated in the diagram of Fig. 6b.

At the bottom of the diagram in Fig. 6b the sequence of testing of the panels is shown. It has to be noted here that the biaxial tests were carried out after the uniaxial testing programme was completed.

During the execution of the uniaxial testing programme with the first tested specimen in which cracking at the tear strap ends occurred (specimen 3b-A, see Fig. 6b) no special measures were taken. With the next tested panel (specimen 3b-B, see Fig. 6b) the crack tips were stop-drilled with 5 mm \emptyset holes and these holes were cold worked. It has to be noted that such an action could not be applied before the cracks in the skin had passed the tear strap edges, implying that the crack had a length then of about 2 inches. Stop-drilling of these cracks was found to be not very effective: fairly soon after stop-drilling was carried out the panel failed in mode B across the stop-drilled cross section. Therefore with all other panels tested subsequently (both uniaxial and biaxial) the propagation of the cracks at the tear strap ends was stopped by applying a so-called "ball-indentation" process in the crack tip regions. During such a process residual compressive stresses are built up in the material at the crack tip by pressing a steel ball of 8 mm \emptyset in the material by means of a riveting hammer, meanwhile supporting the panel at the back side locally by means of a heavy piece of

metal. As is shown in Fig. 6b (see explanation given for specimen 2b-B) this crack arresting process had to be repeated a number of times during the test continuation because new cracks initiated at other locations or reinitiation of cracks at the hammered crack tips occurred later on. It can be seen from Fig. 6b that with the biaxial tests application of the BI-process appeared to be more effective than with the uniaxial tests: although with the biaxial tests the BI-process generally was applied for the first time before any crack initiation in the lap joint was discovered, all biaxially tested panels failed in mode A or mode C whereas in the uniaxially tested panels in which the BI-process was applied, all but one failed in mode B (panel 4c-A failed in mode C).

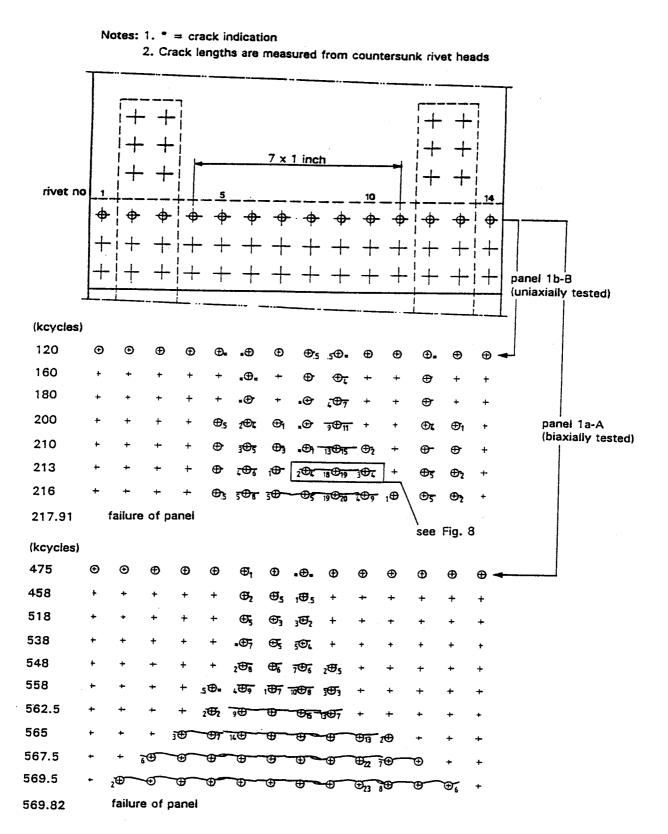
Fig. 7 Crack initiation and propagation in critical rivet row for uniaxial and biaxial specimens (typical)

Fig. 7 illustrates the crack initiation and propagation behaviour being typical for the uniaxially and biaxially tested panels. In the lower half of this figure this behaviour is shown for the critical rivet row as a function of the number of kcycles. It is shown that in the uniaxially tested panels cracks initiated at various locations along the rivet row and just before panel failure (i.e. after 213 kcycles) these cracks still had not linked up. At that moment a photograph was made of the area indicated in Fig. 7. This photograph (see Fig. 8) shows that cracks had propagated from adjacent rivets in opposite directions, more or less parallel to each other without showing linking up.

In the biaxially tested panel shown in Fig. 7 crack initiation remained limited to three adjacent rivets and linking up of these cracks occurred well in advance of panel failure.

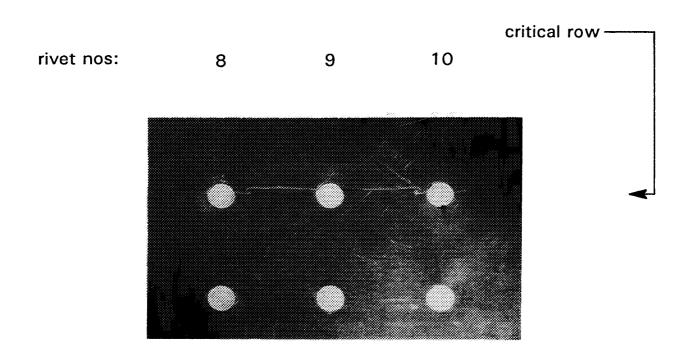
Fig. 8 Photograph of cracks in uniaxially tested specimen 1b-B

* photograph is taken after 213 kcycles } see Fig. 7
* panel failure after 217.91 kcycles

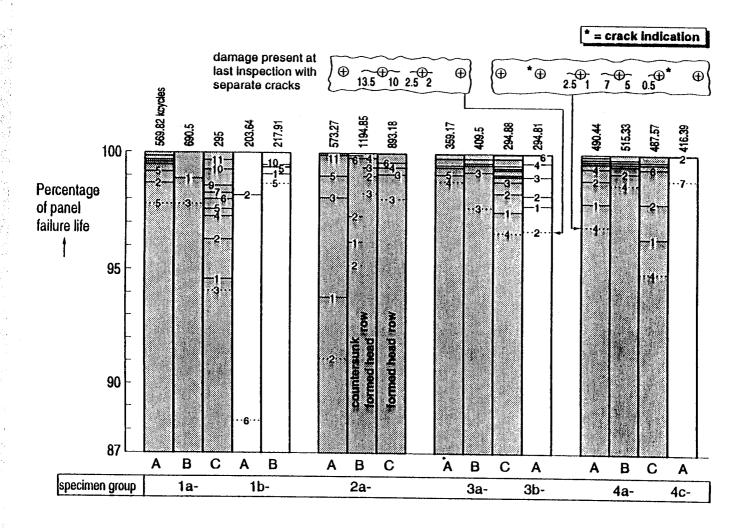
Fig. 9 Development of MSD after the last inspection with separate cracks

The results of Table 5 are plotted in Fig. 9. The moments of inspection are expressed in this figure as percentages of panel failure life. The inspections that represent the last inspection at which separate cracks were found are drawn dotted. The number of cracked rivets being present at that moment are given (see sketches in Fig. 9). The other levels in Fig. 9 represent the levels at which, successively, inspections were carried out and the numbers given at these levels pertain to the number of rivet spacings that were found to be cracked during these inspections.

It can be observed from Figure 9 that the last inspections at which separate cracks were found generally were carried out at levels above 95% of the panel failure lives and consequently development of these cracks across the rivet row ultimately leading to panel failure occurred in less than 5% of the life until failure.
